## REVIEW ARTICLE

## THE WHOLE-IMAGE ANALYSIS AND RESEARCH OF ROCK ART DISEASE IMAGE OF HUASHAN MOUNTAIN, NINGMING COUNTY

Ningming Huashan Rock Art, Disease-image, Full Map, Data Statistics

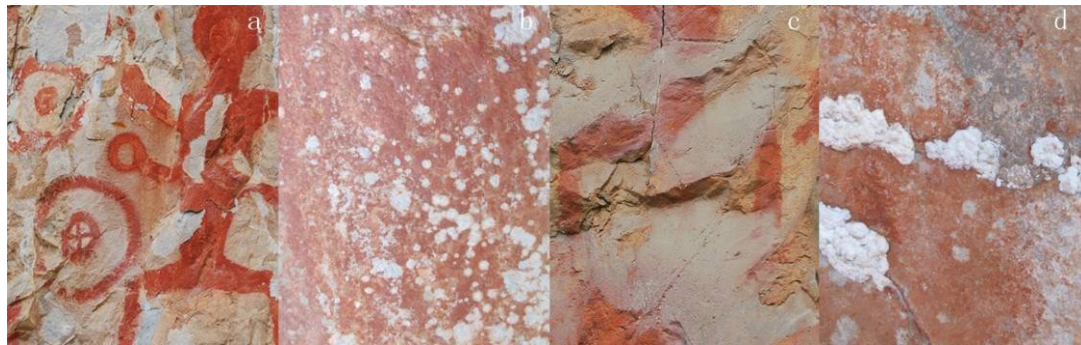
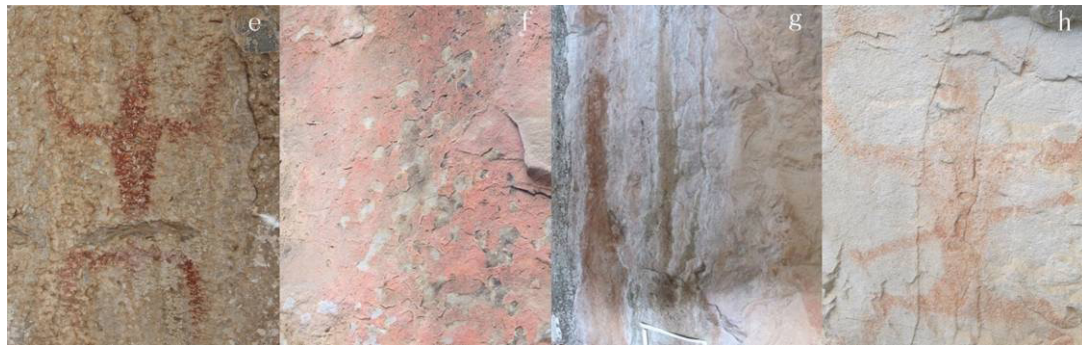
**Figure 2:** Part of the rock disease (made by the author)

(a) Flaky rock spalling; (b) Pigment layer pulverized off; (c) Dust cover; (d) Calcium carbonate cover

(e) Surface scaling; (f) Pigment layer flake off; (g) Karst coverage; (h) Fading

or lava, pigment powdering and falling off, calcium carbonate crystal, lamellar shedding of pigment and other diseases, as shown in Figure 2 (b), (d) and (f). These diseases were usually located in the range of painting marks in the rock art images and were distributed in a point-like manner, which has little impact on the overall recognition and contour tracing of the rock art image (Table 3). During this process, we only needed to accurately draw the outline and local details of the diseased images, and flat paint the full color in the outline area. Karst or water mark affected the rock art images from top to bottom, accounting for about 6.7% of the repair area. As shown in Figure 2 (g), the cliff surface was pink or dark brown. As some places became stalactites or

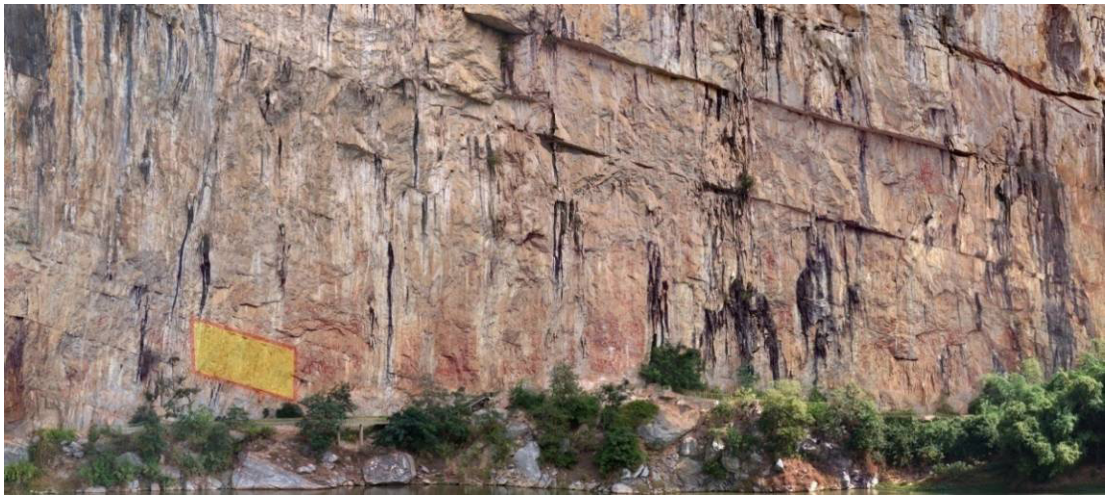
Figure 3: The location of the full image area (made by the author)

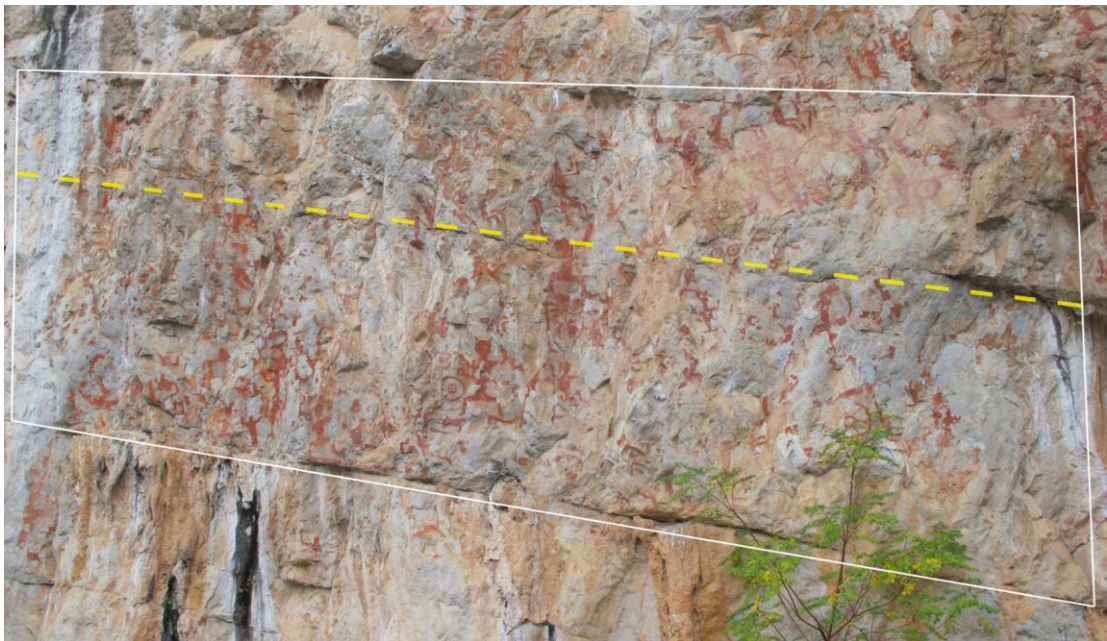
Figure 4: The preservation status in the whole image area (made by the author)

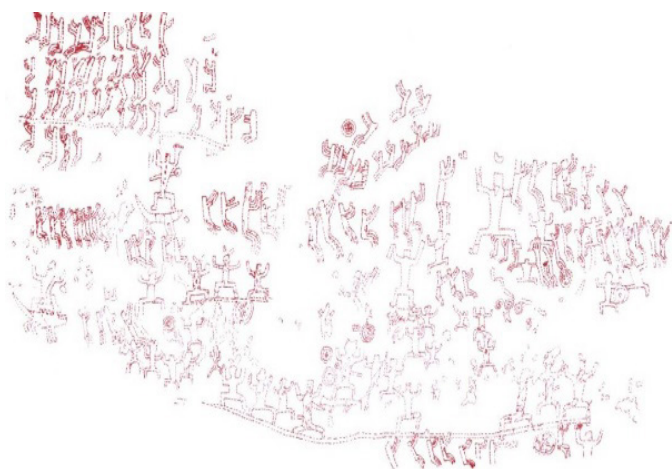
Figure 8: The contour of the diseased image (prepared by authors)

by little, and finally the rock art images in the whole area became fully identifiable. The relationship of all images in the region before and after the completion of the full image is shown from Figure 7 to Figure 9.

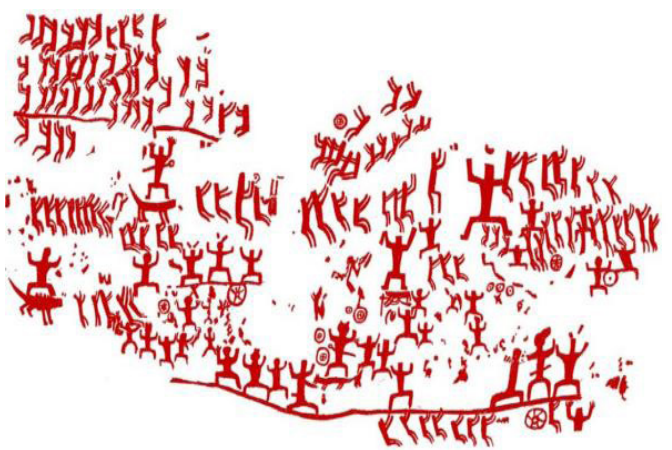
Figure 9: The completion of the image (prepared by authors)
